Site Inspection, UMETCO, Deremo/Peterson Mine, M/037/025, San

Juan County, Utah

Photographs

Inspection Dated: July 1, 2004; Report Dated: August 20, 2004

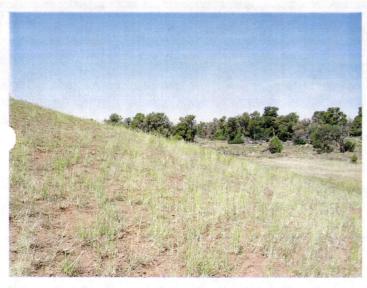
Except for the north-facing slope, the operator has had difficulty establishing vegetation at this site. There is good perennial cover on the north slope (Photo 1), but most vegetation on the rest of the site is weeds (Photos 2 and 3).

Photo 1. North side of the waste pile. This is atypical of the site.

I suggest that the operator try one more time to seed this site. This time, particular efforts should be made to obtain good quality seed and to seed as soon as possible after surface preparation. The Division should be notified as far in advance as possible of the date when seeding will be done.

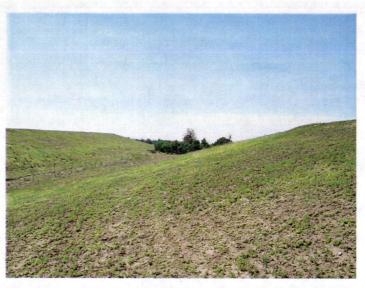
The area has been in a drought for several years, but there was fairly good precipitation this past spring and early summer. I am unsure why last fall's seeding would not have resulted in better vegetation.

Photo 2. The east side of the waste pile. Nearly all of the plants shown in this photo are weeds, and most of the pile looks like this.

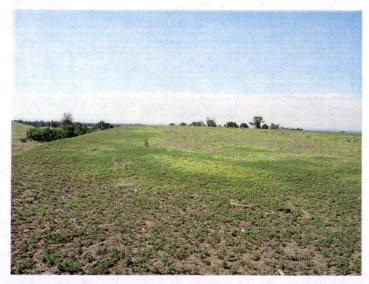
Photo 3. The top of the pile.
